BUREAU OF SHIPS GROUP TECHNICAL INSPECTION REPORT

USS GASCONADE (APA85)

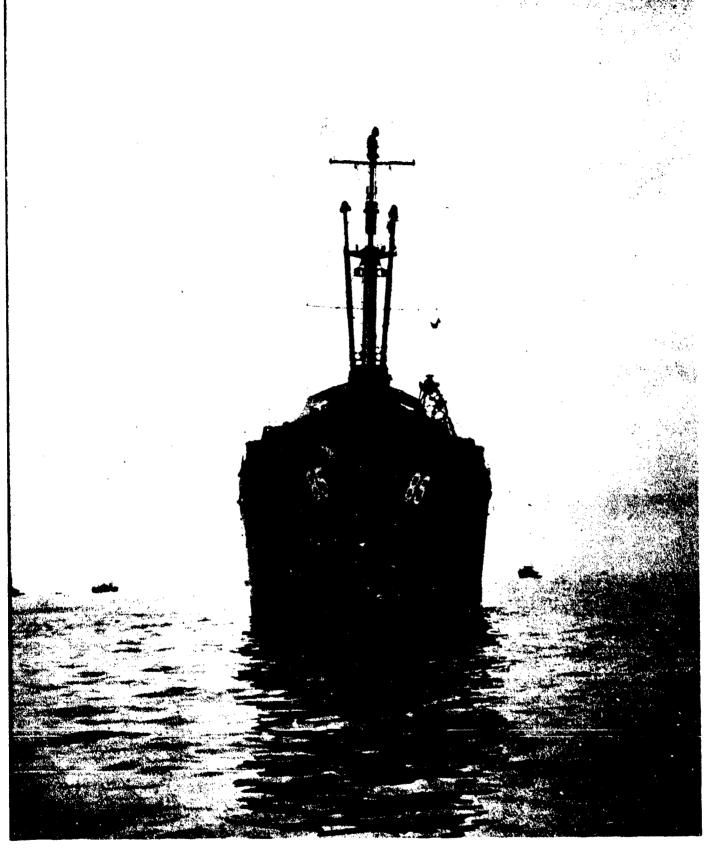
AB-CR-227-289-53. View from dead ahead after Test B.

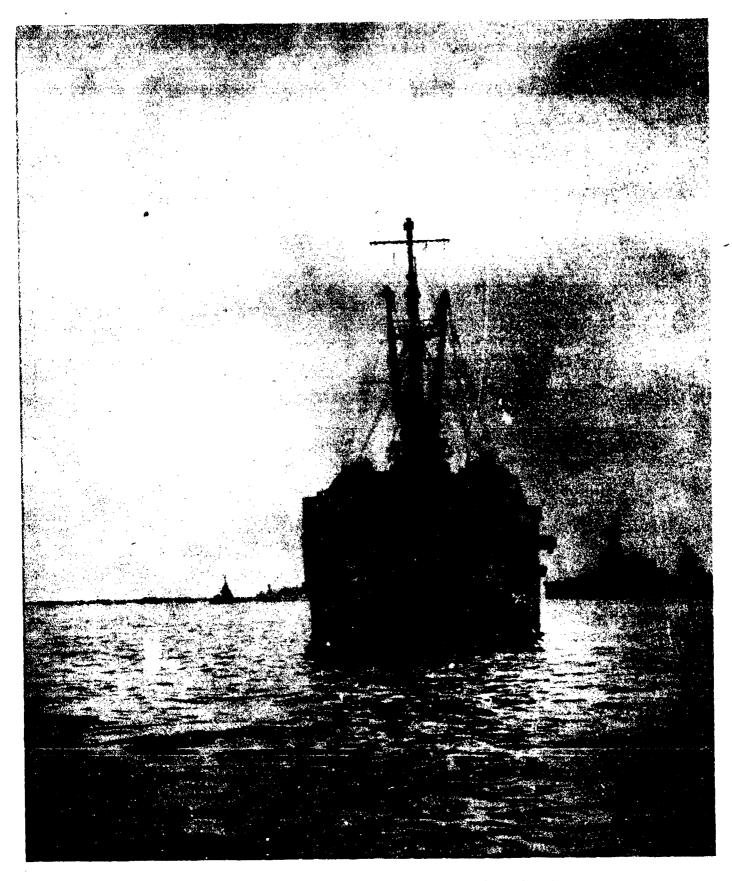
AB-CR-227-289-49. View from astern after Test B.

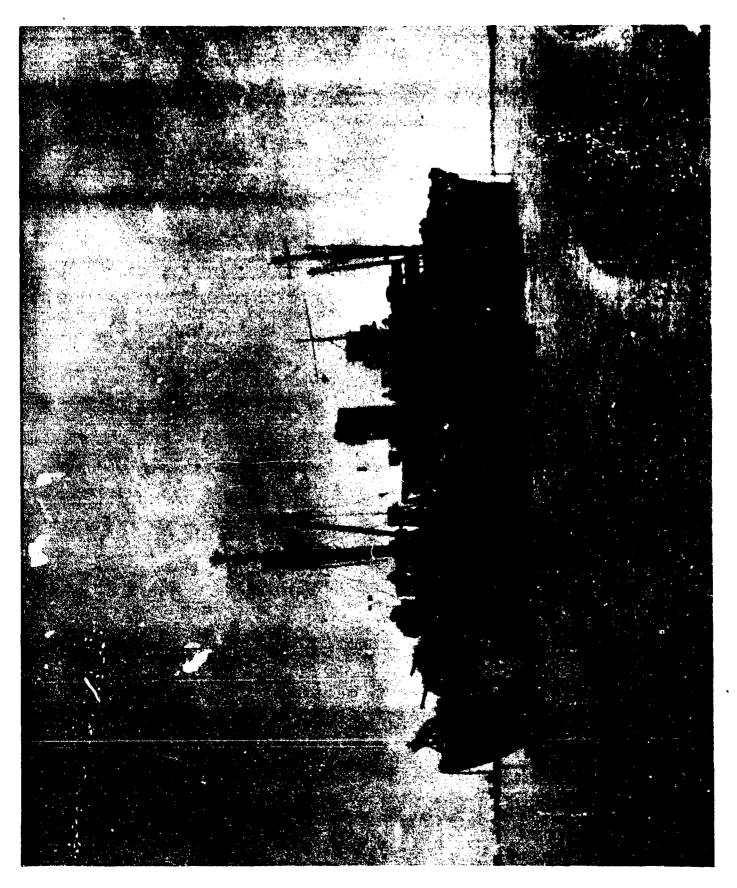
AB-CR-227-289-56. View from off starboard quarter after Test B.

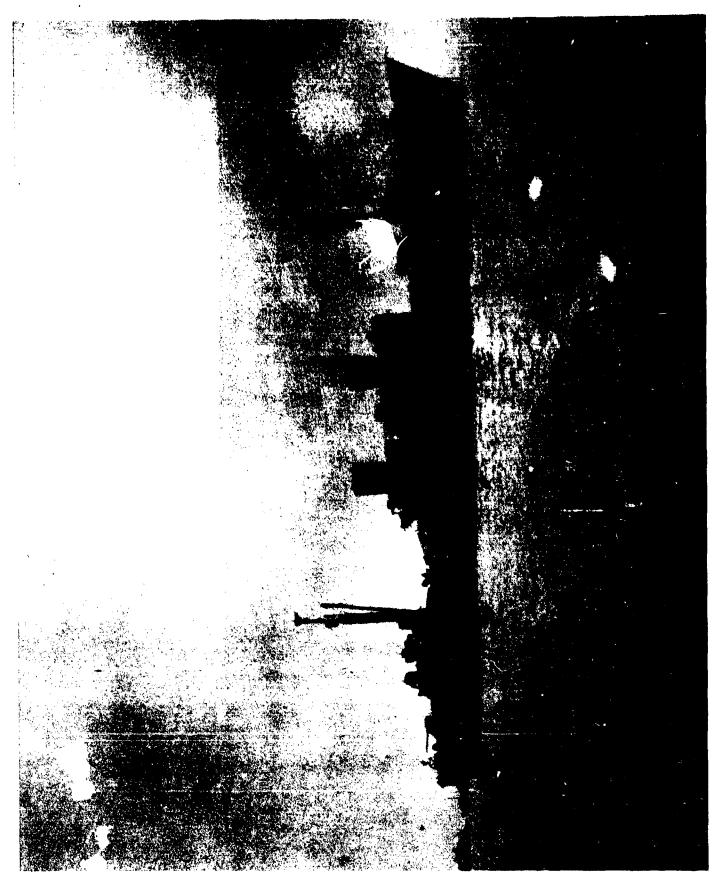
AB-CR-227-289-55. View from off starboard beam after Test B.

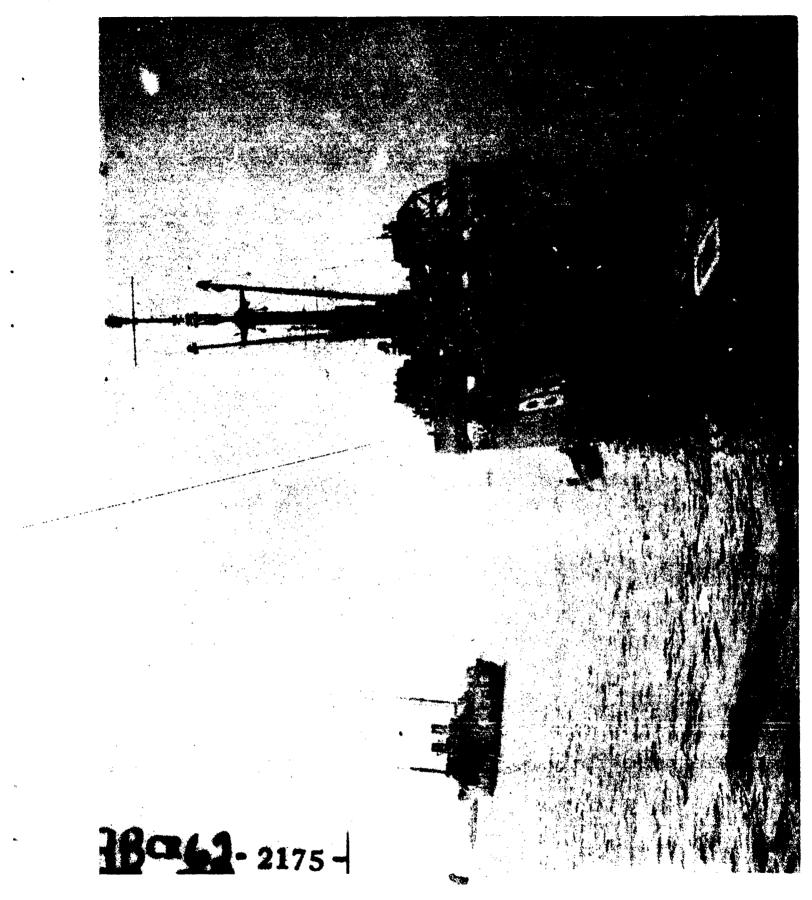
AB-CR-62-2175-2. Close-up from astern. Note slight port list.

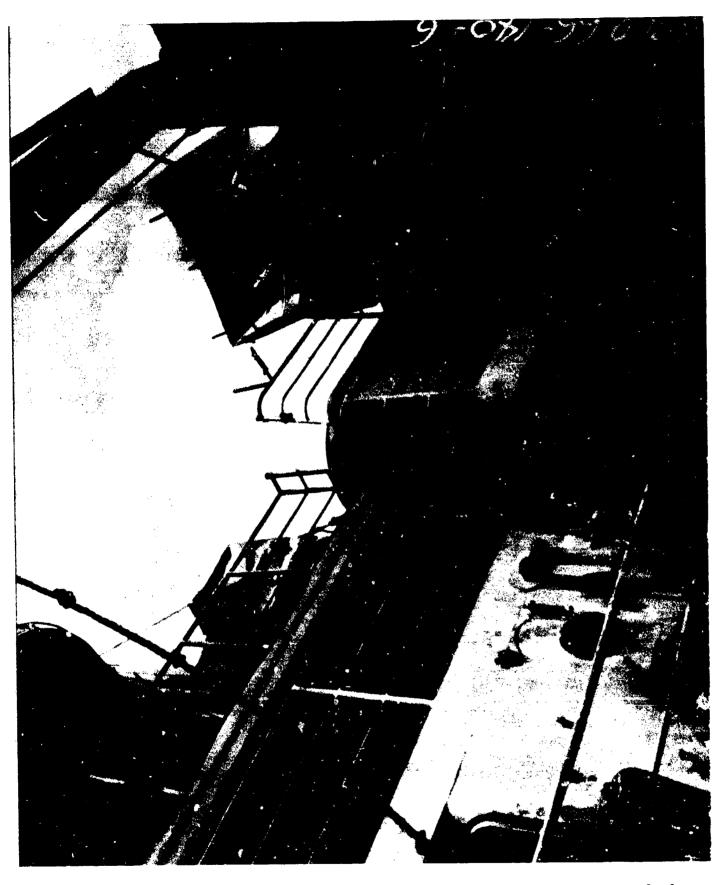
AB-CR-66-140-6. Looking forward and inboard from upper deck, starboard, showing damaged flag bag and locker on signal bridge.

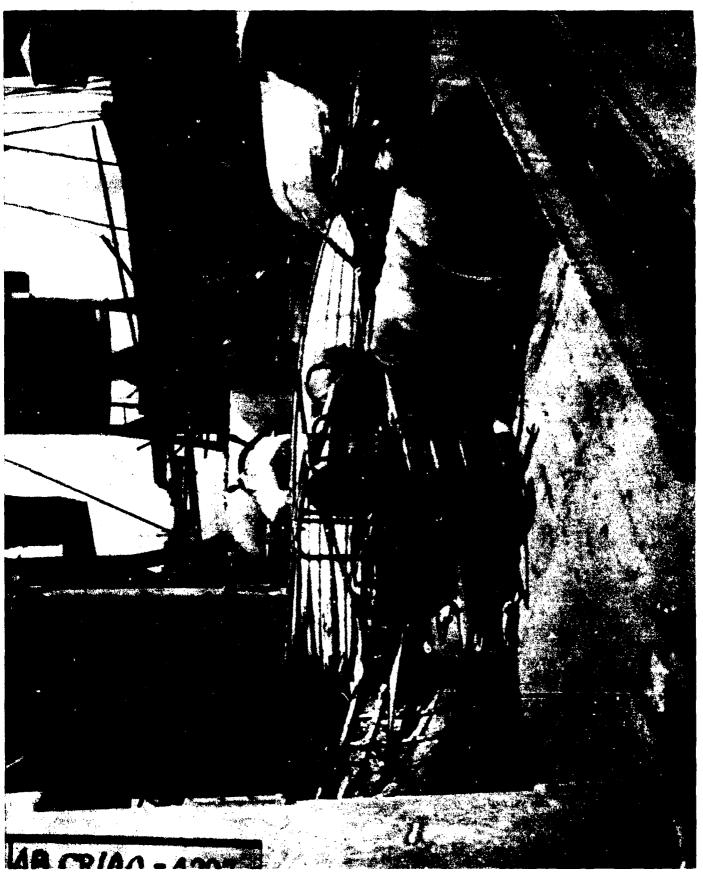
AB-CR-100-4207-10. Looking forward and to port on after deck house top showing wrecked boat and damaged emergency steering equipment and ventilation.

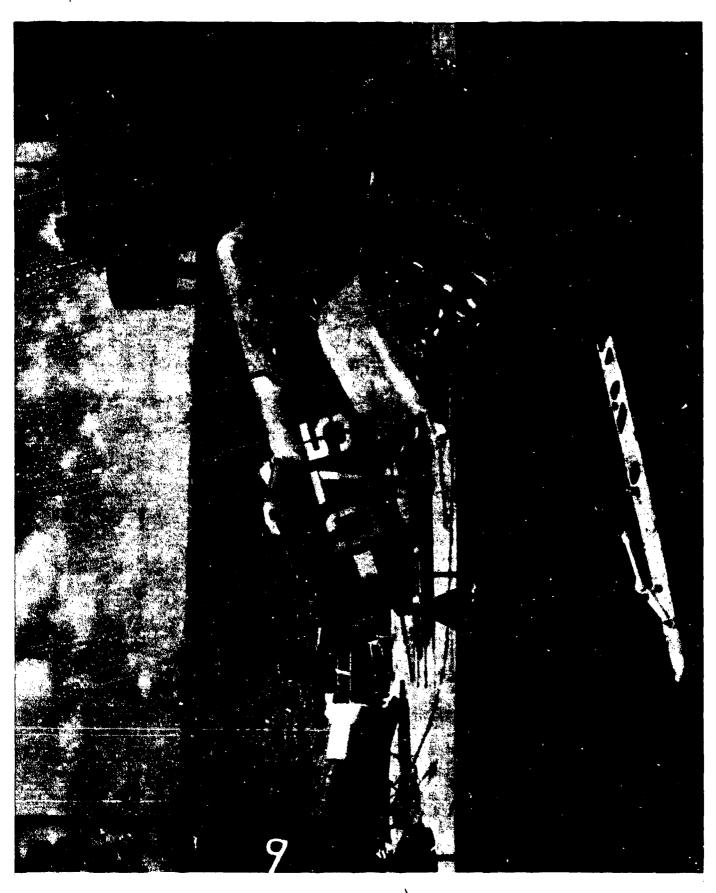
AB-CR-175-2184-9. View from starboard, showing demolished airplane on upper deck at frame 110. Refer to 2995-11.

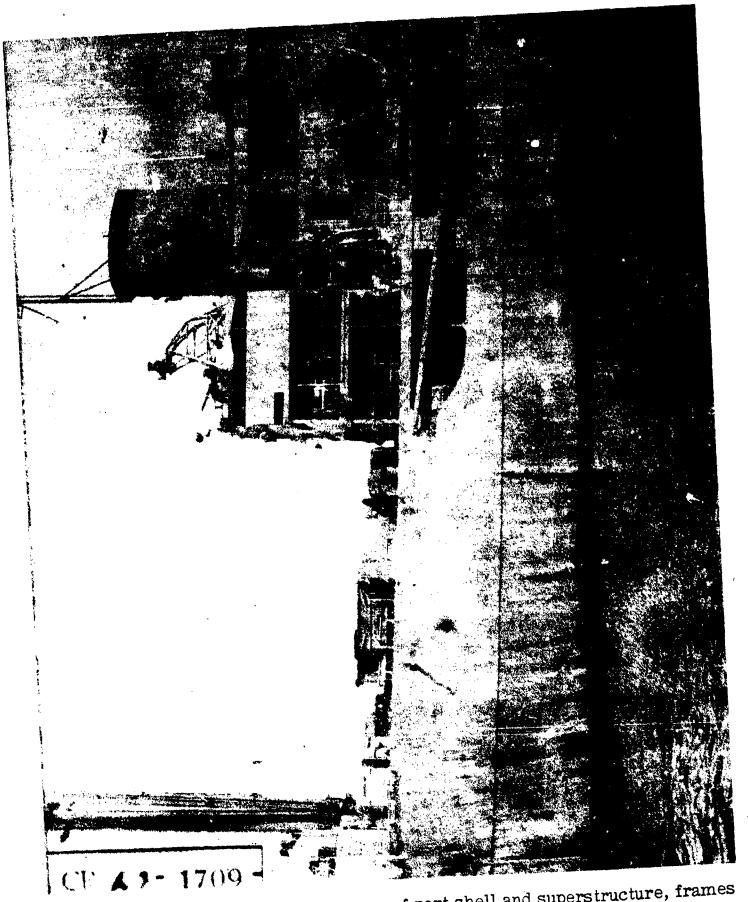
AB-CR-60-1709-3. Close-up of port shell and superstructure, frames 38-80.

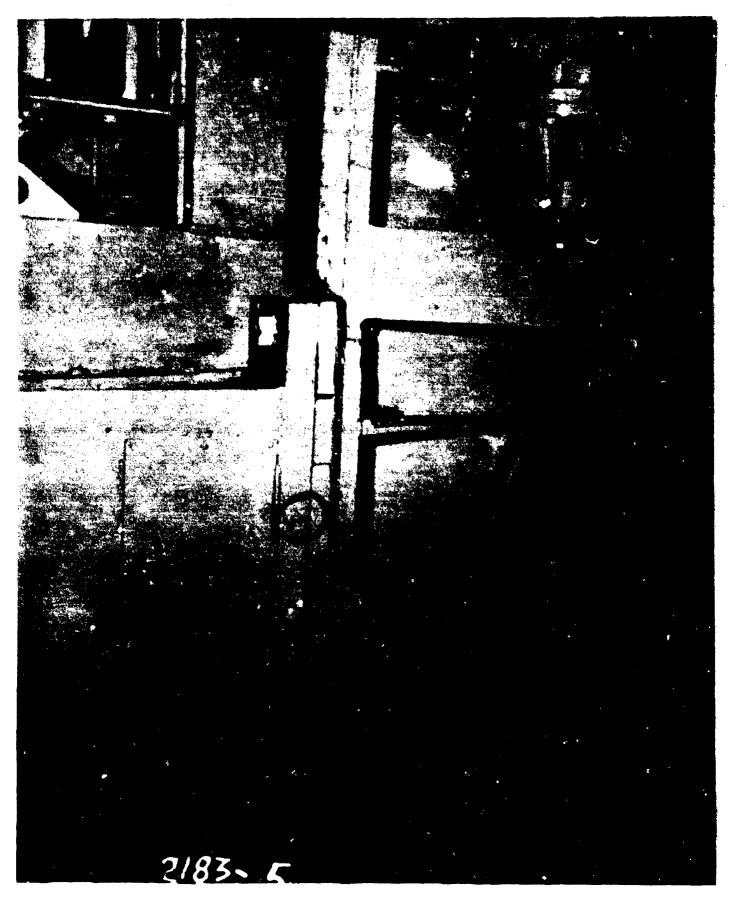
AB-CR-175-2183-5. View in forward machinery space showing strain marks on after starboard bracket of main motor foundation.

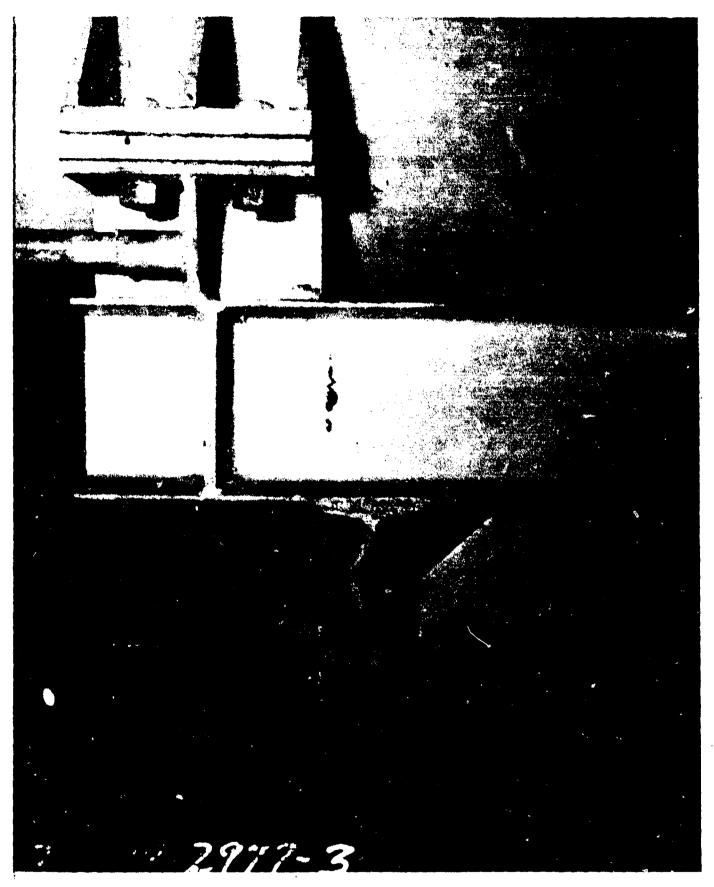
AB-CR-79-2977-3. Forward machinery space, foundation failure under auxiliary condenser.

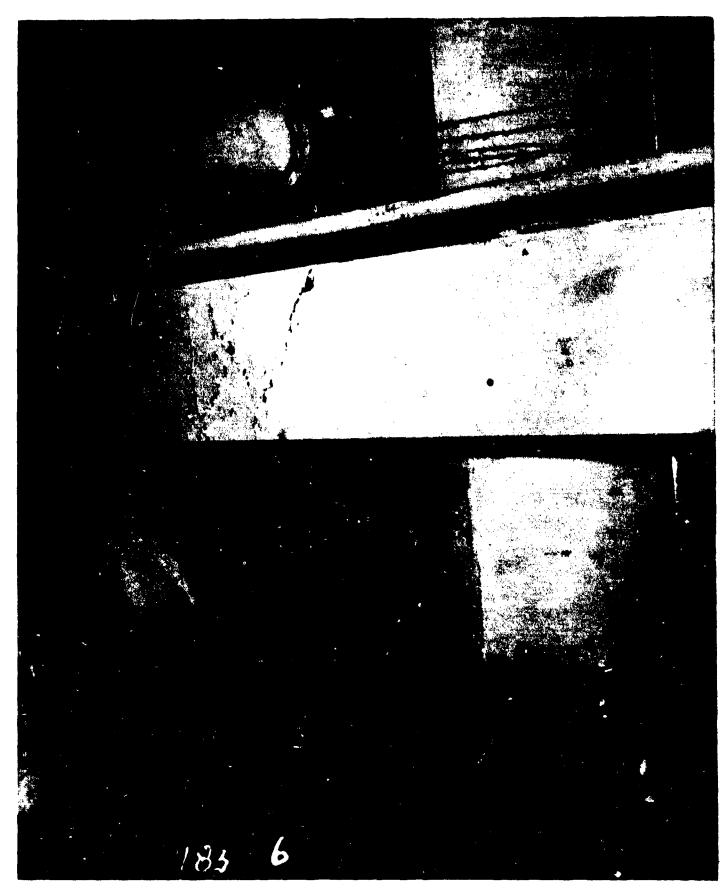
AB-CR-175-2183-6. Forward machinery space, stress lines in paint on pillar at frame 76.

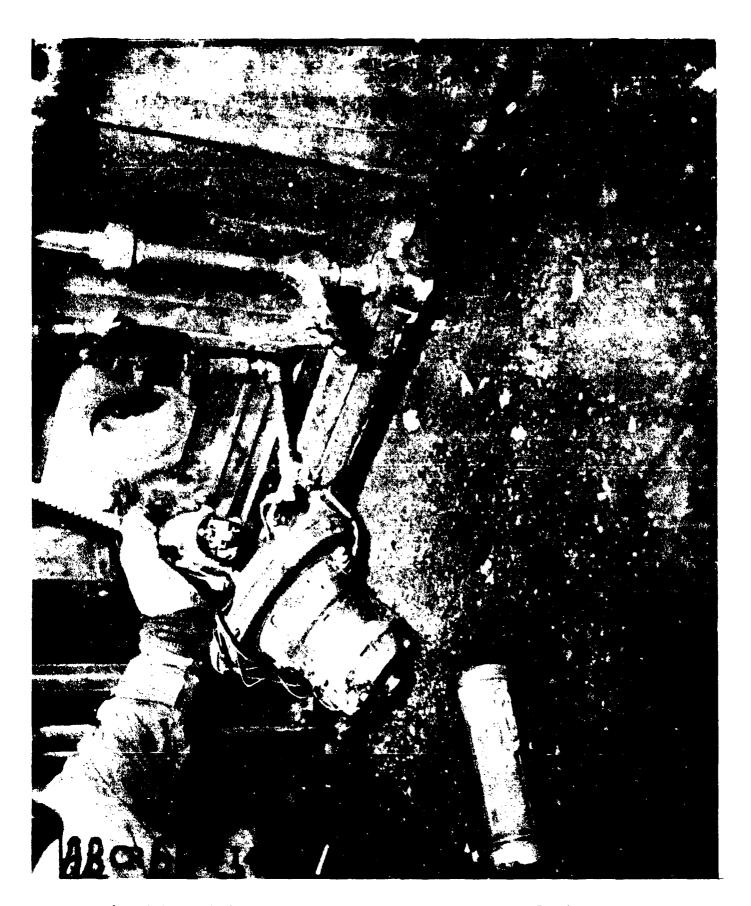
AB-CR-66-140-1. Looking down and to port into No. 1 hold from upper deck showing dislodged and damaged hatch pontoons. These pontoons have been dislodged at the main deck level and one pontoon at the first platform has fallen into the hold.

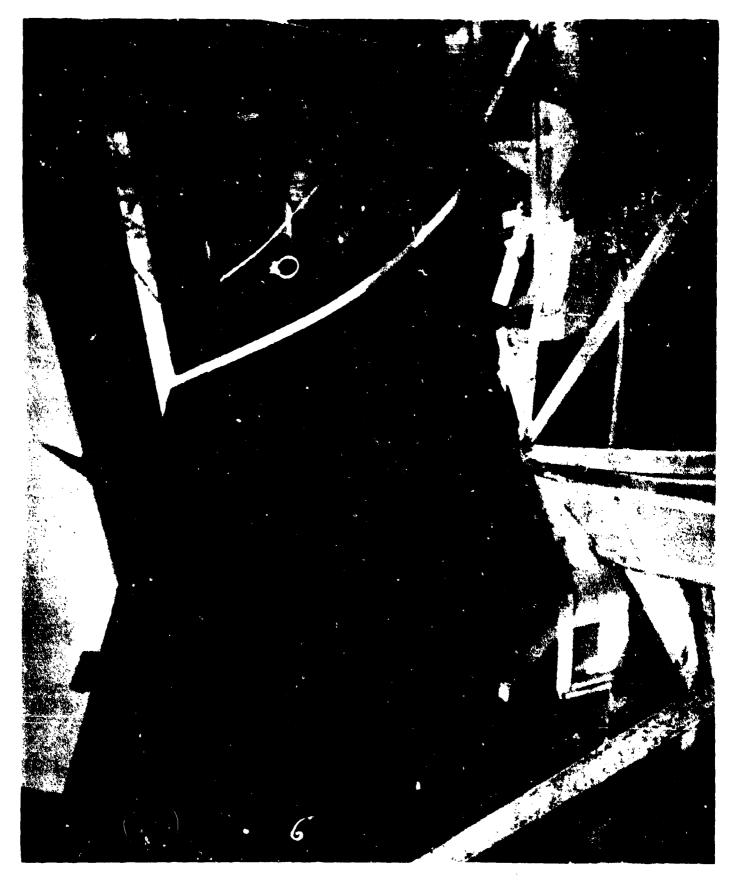
AB-CR-100-4207-6. Looking aft and to starboard on main deck in after cargo hatch area showing dislodged hatch pontoons and bunks.

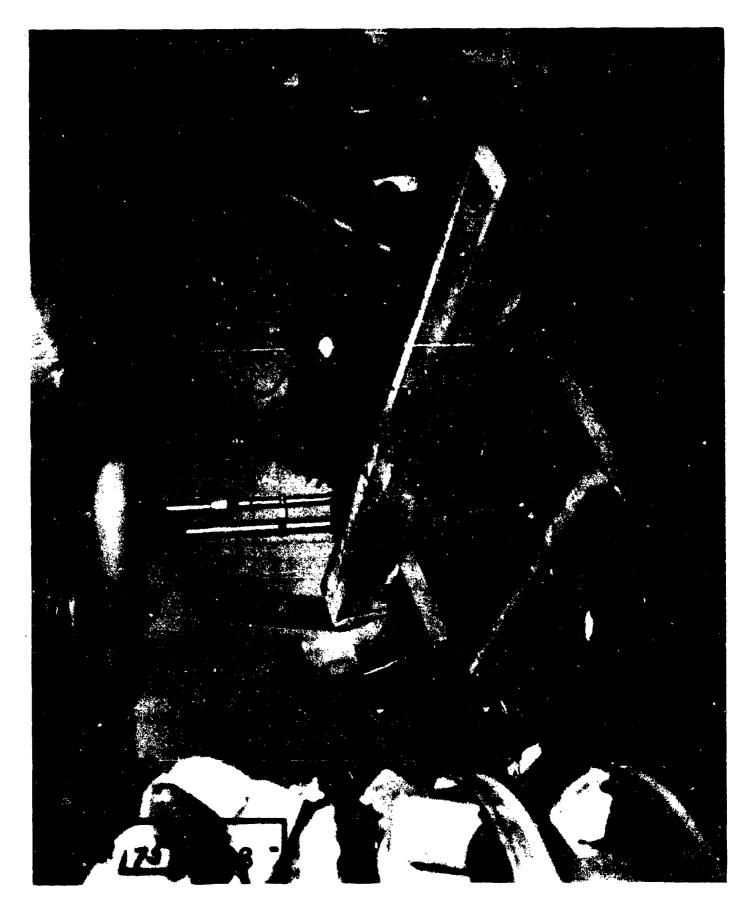
AB-CR-175-2183-10. Looking aft on starboard side in after machinery space on workshop level showing overturned milling machine and work bench.

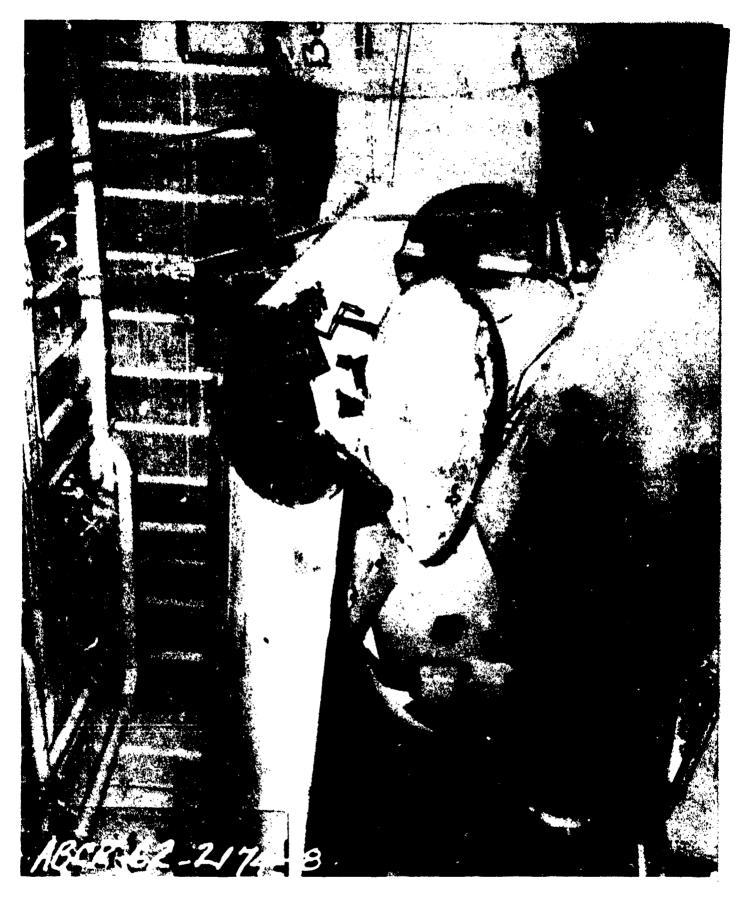
AB-CR-62-2174-8. Damaged airplane in No. 2 hold.

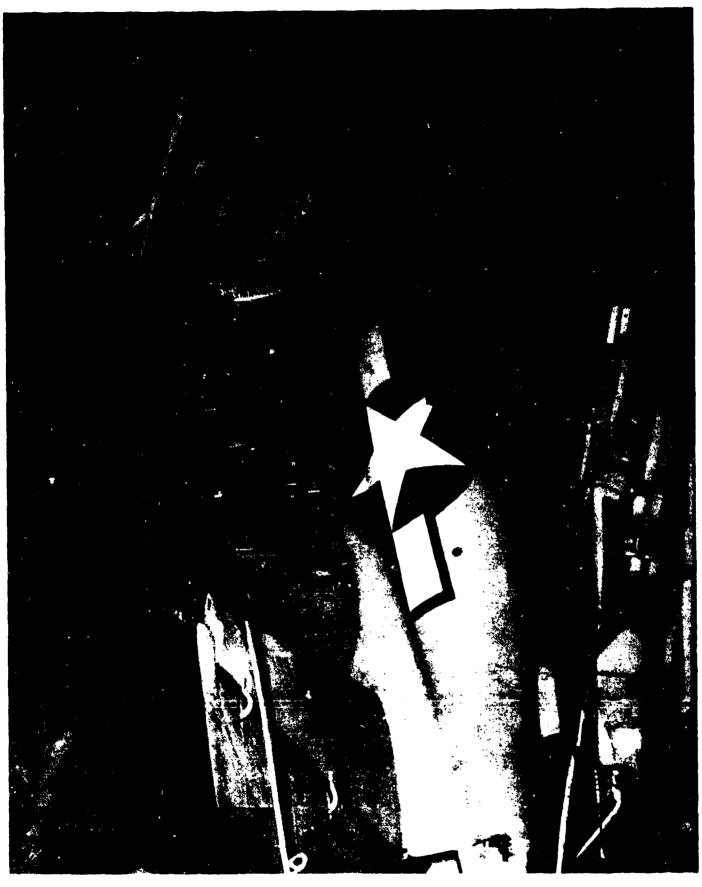
AB-CR-62-2174-9. Damaged airplane in No. 2 hold.

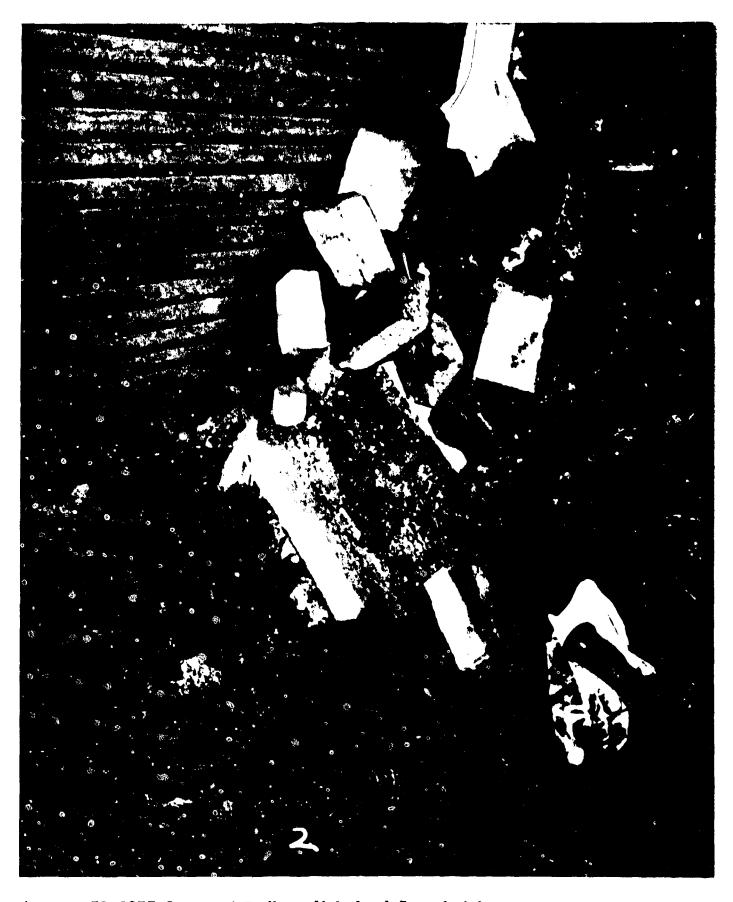
AB-CR-79-2977-2. No. 1 Boiler, dislodged floor brick.

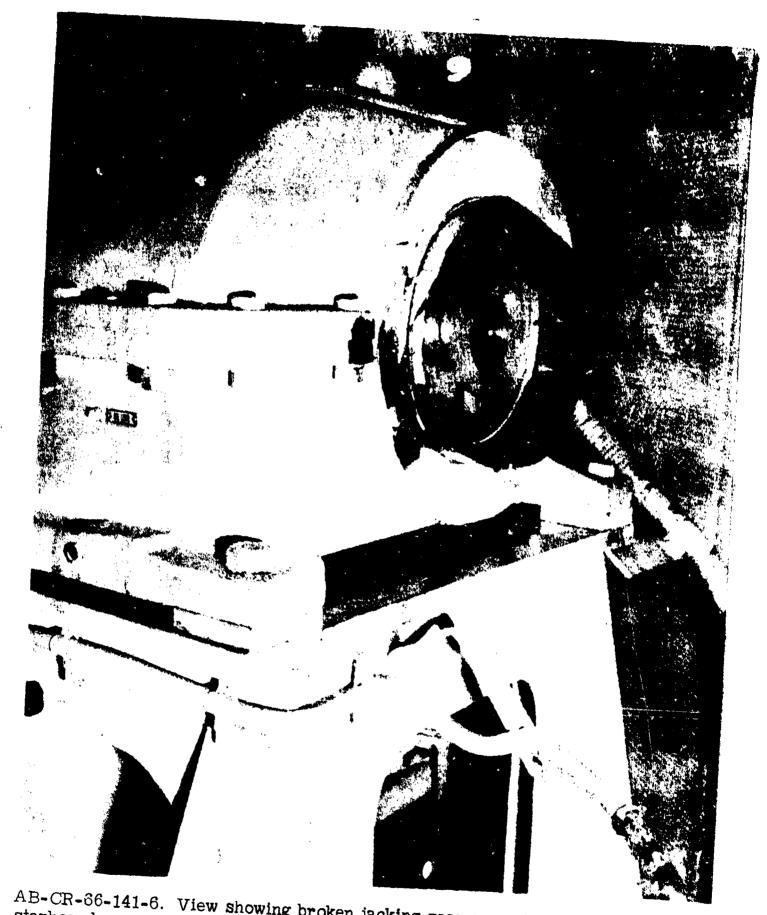
AB-CR-66-141-6. View showing broken jacking gear assembly, starboard.

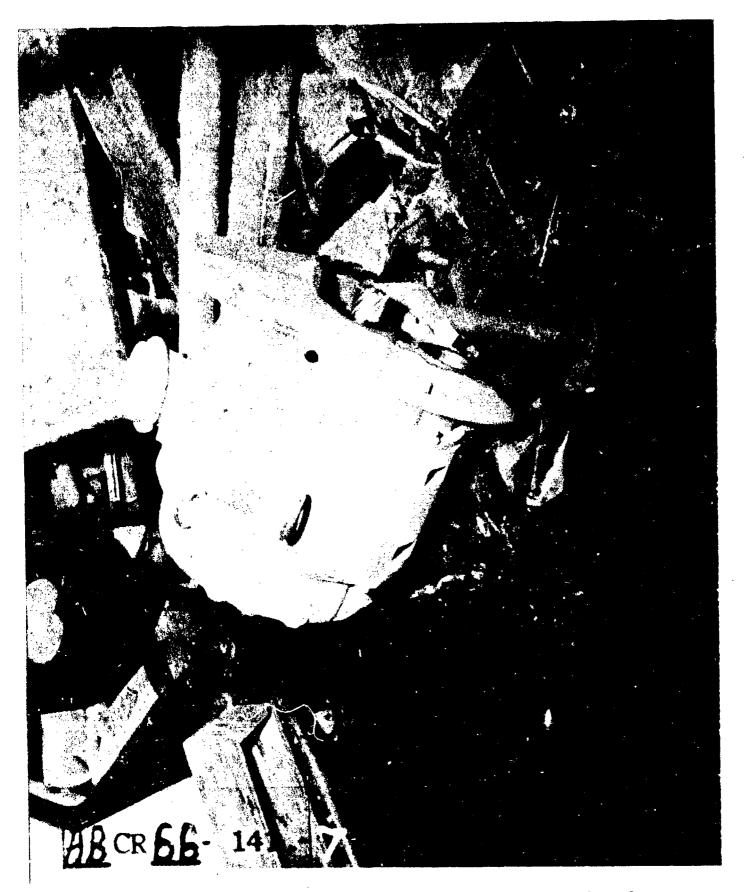
AB-CR-66-141-7. Jacking gear motor on deck, starboard.

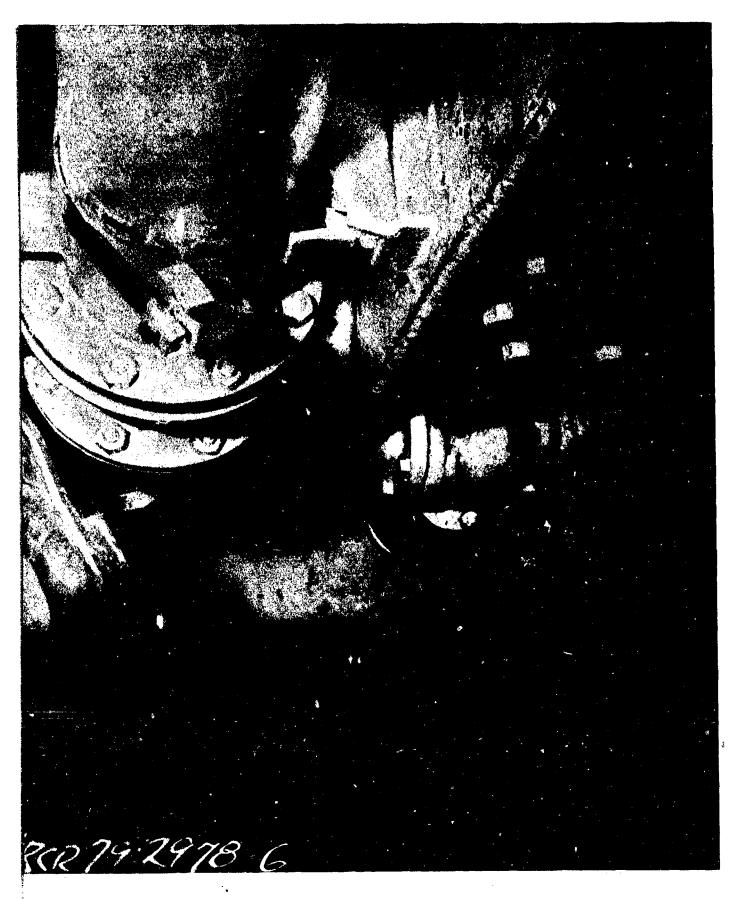
AB-CR-79-2978-6. No. 3 A.C. Auxiliary generator.

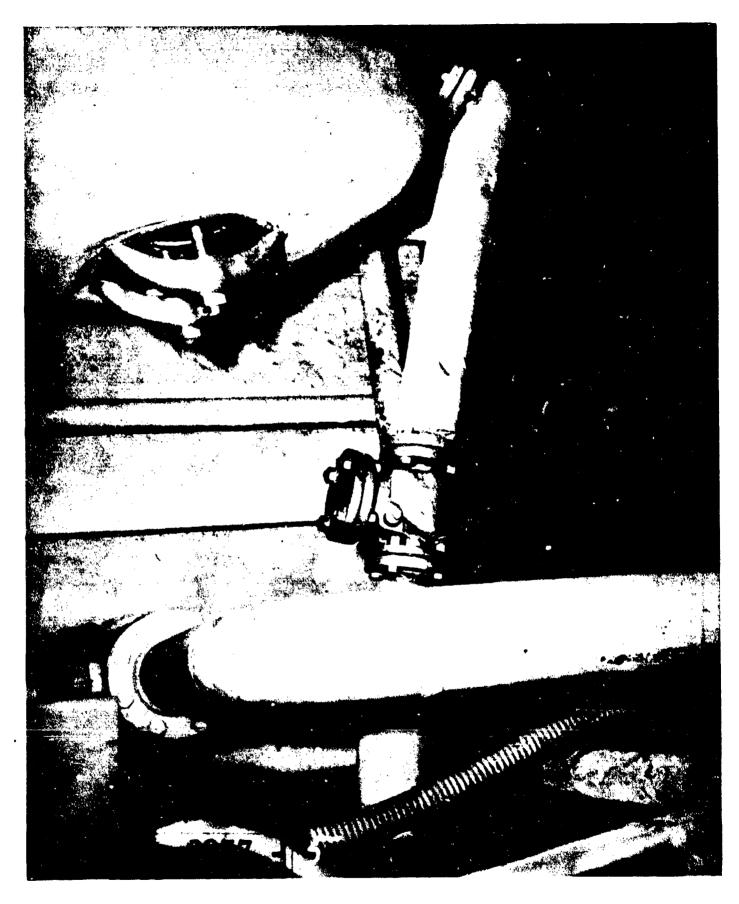
AB-CR-79-2977-5. Hot water heater.

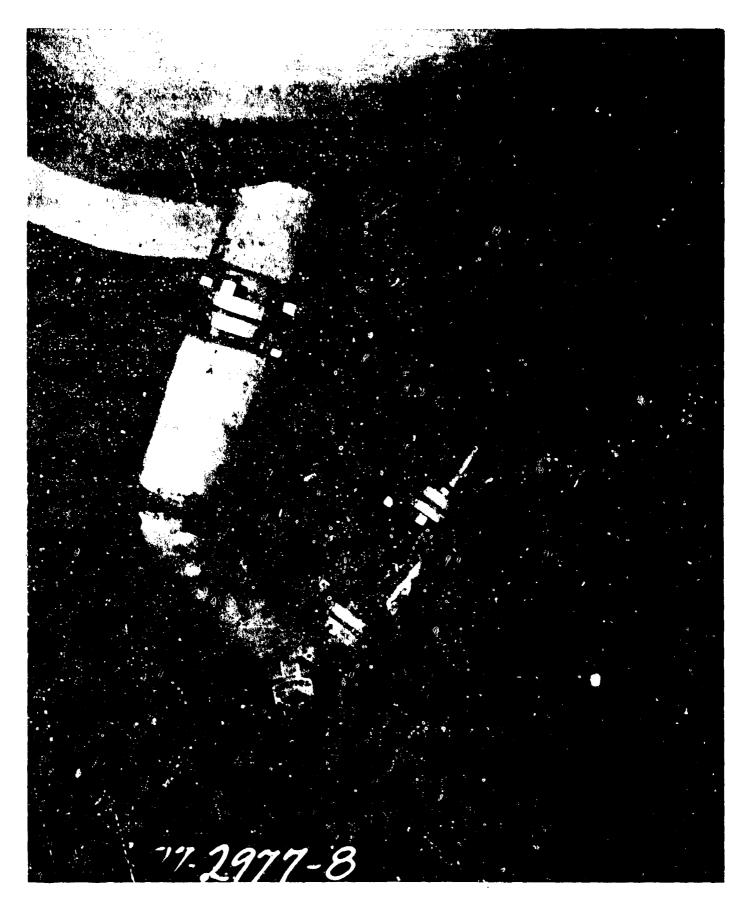
AB-CR-77-2977-8. Hot water heater.

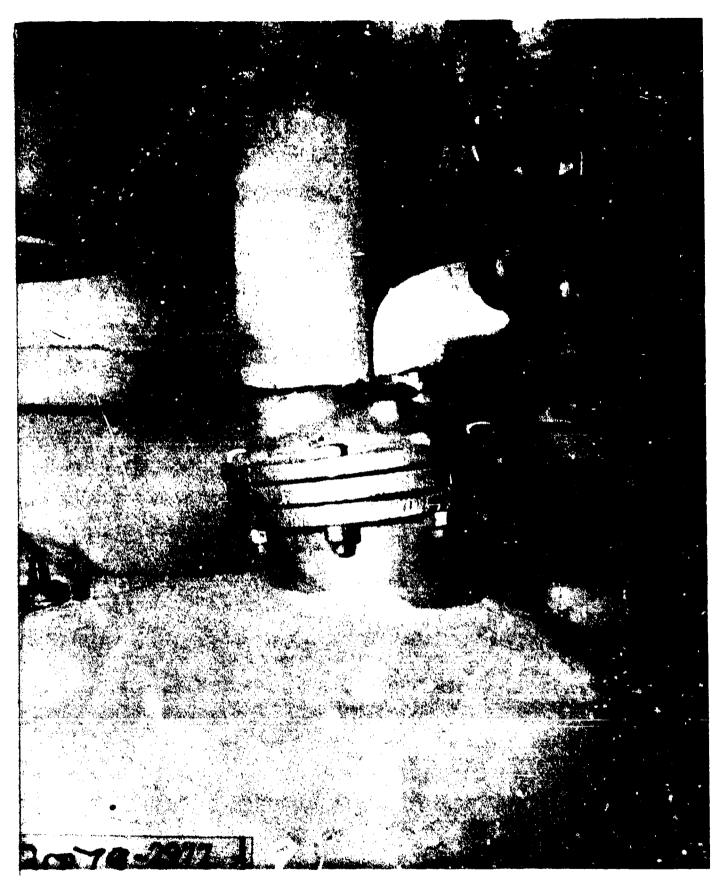
AB-CR-79-2977-9. Hot water heater.

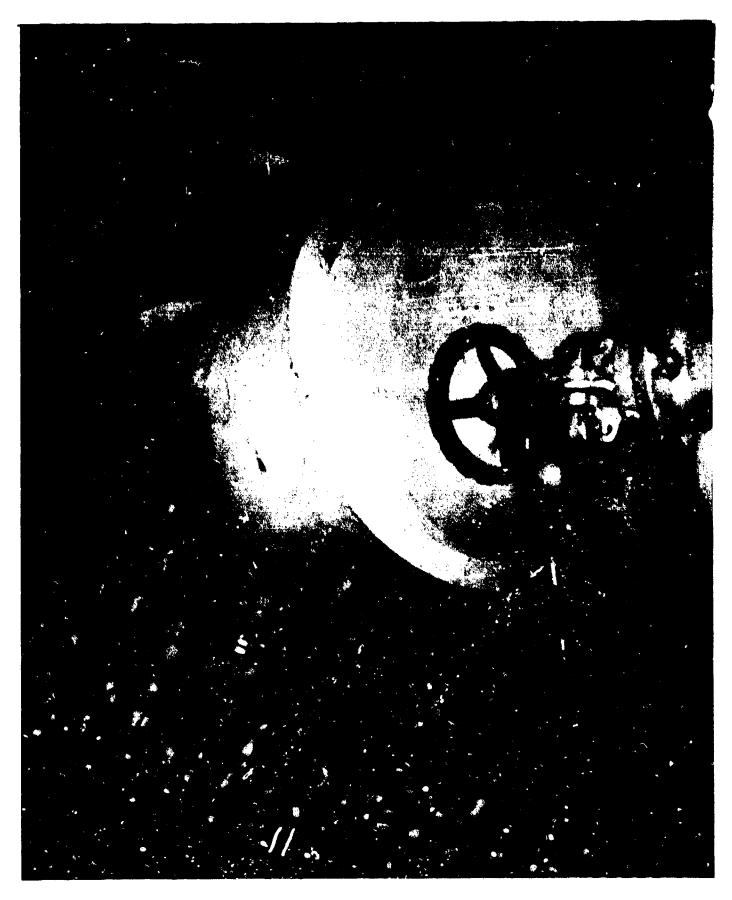
AB-CR-79-2977-11. Hot water heater.

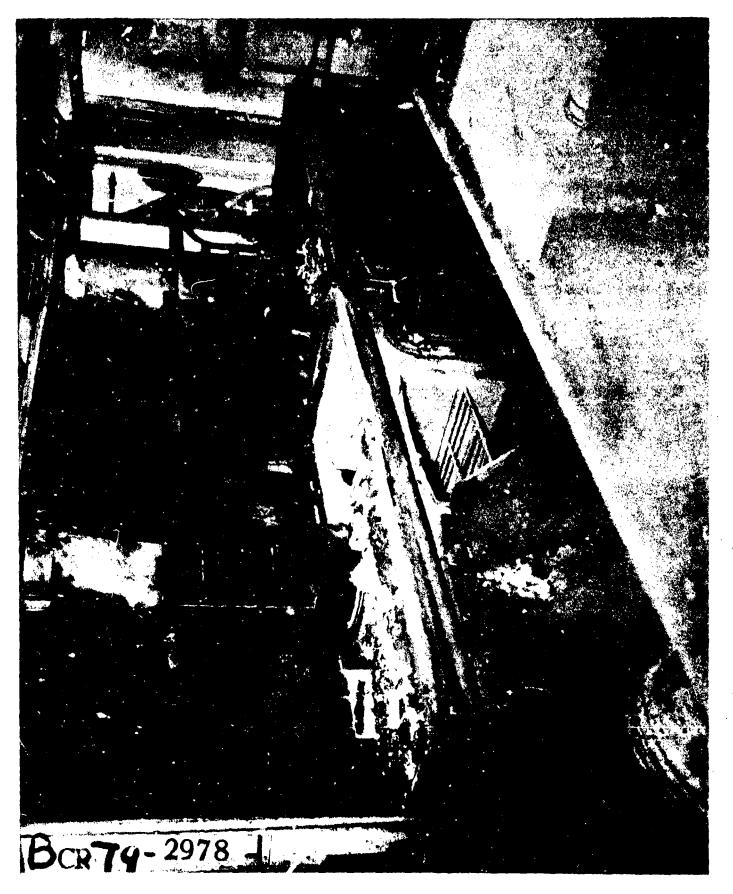
AB-CR-79-2978-9. Galley ranges.

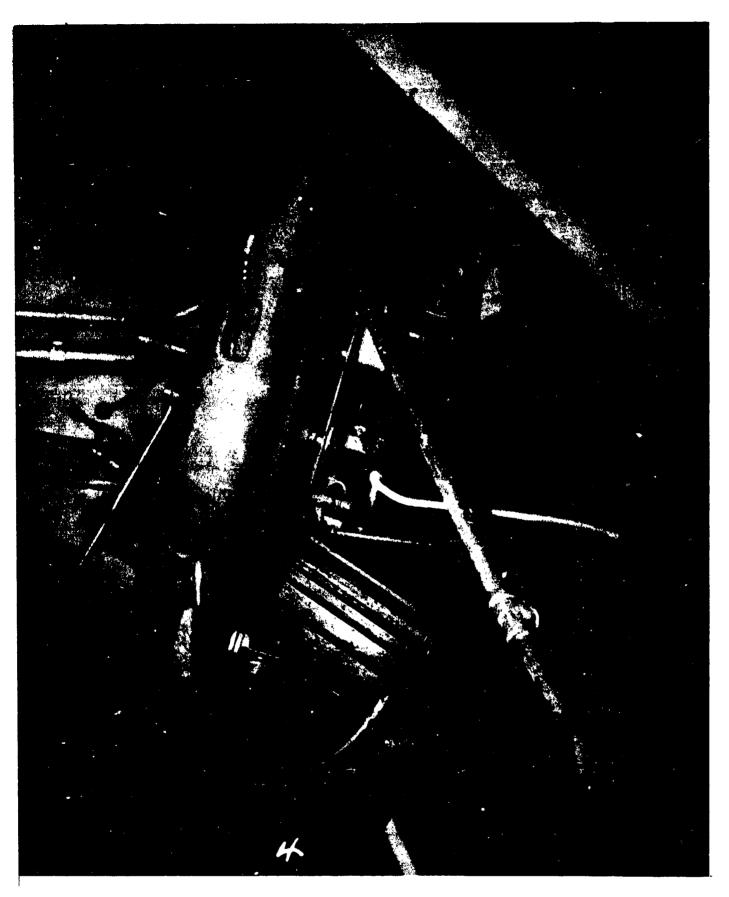
AB-CR-79-2978-4. Milling machine.

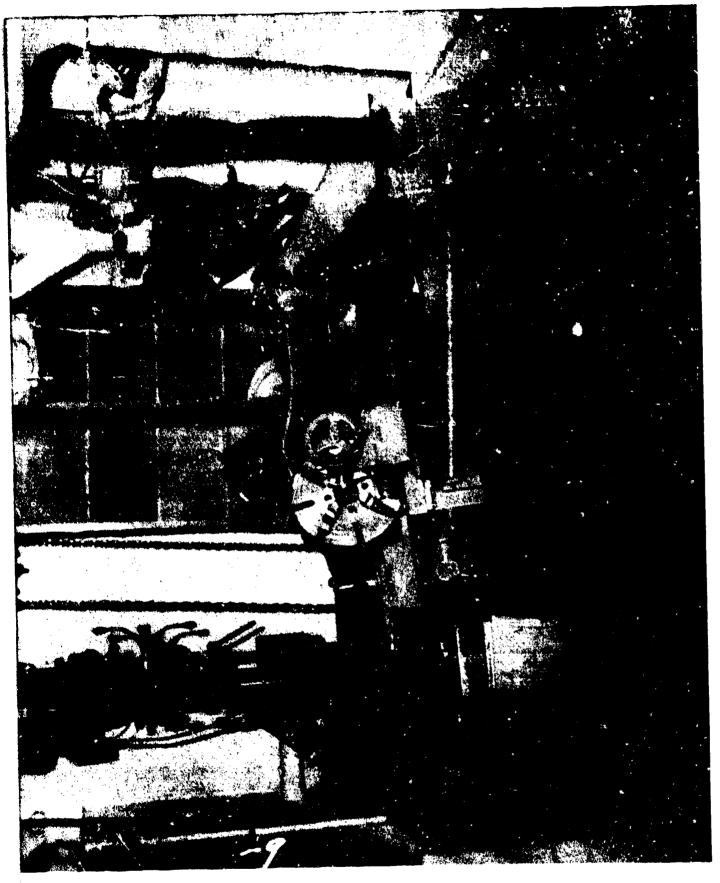
AB-CR-175-2183-9. Drill press and lathe.

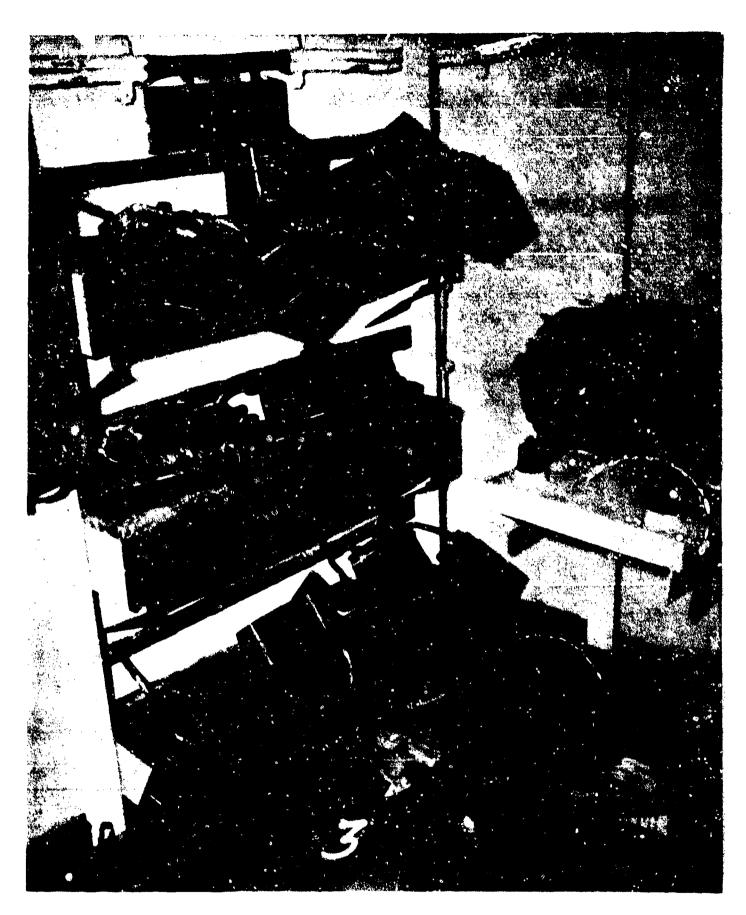
AB-CR-66-141-3. Batteries for the master gyro located in the I.C. room.

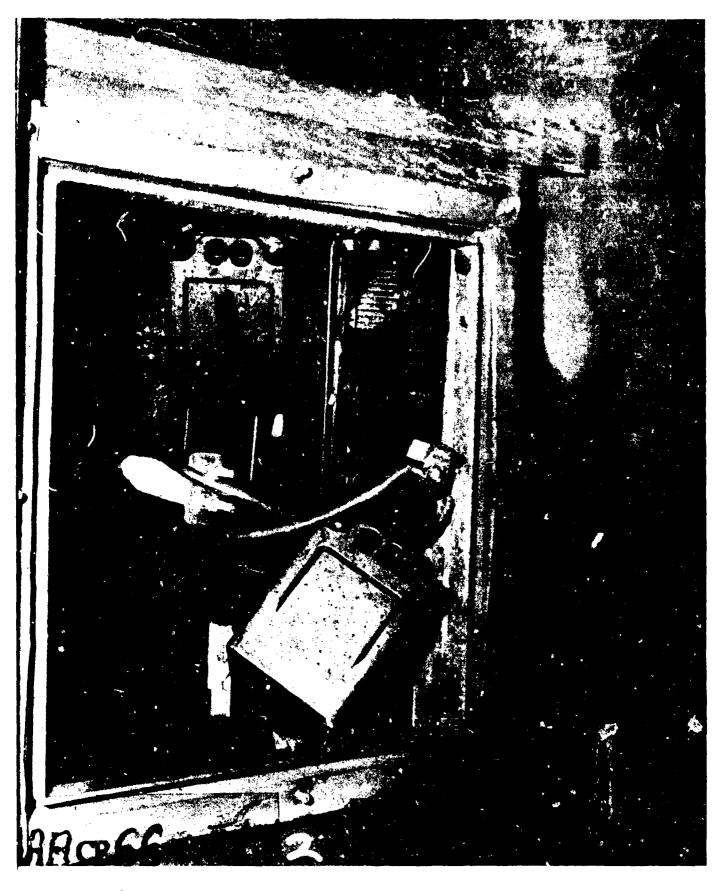
AB-CR-66-143-2. Radio storage batteries located on the port side of the navigation bridge.

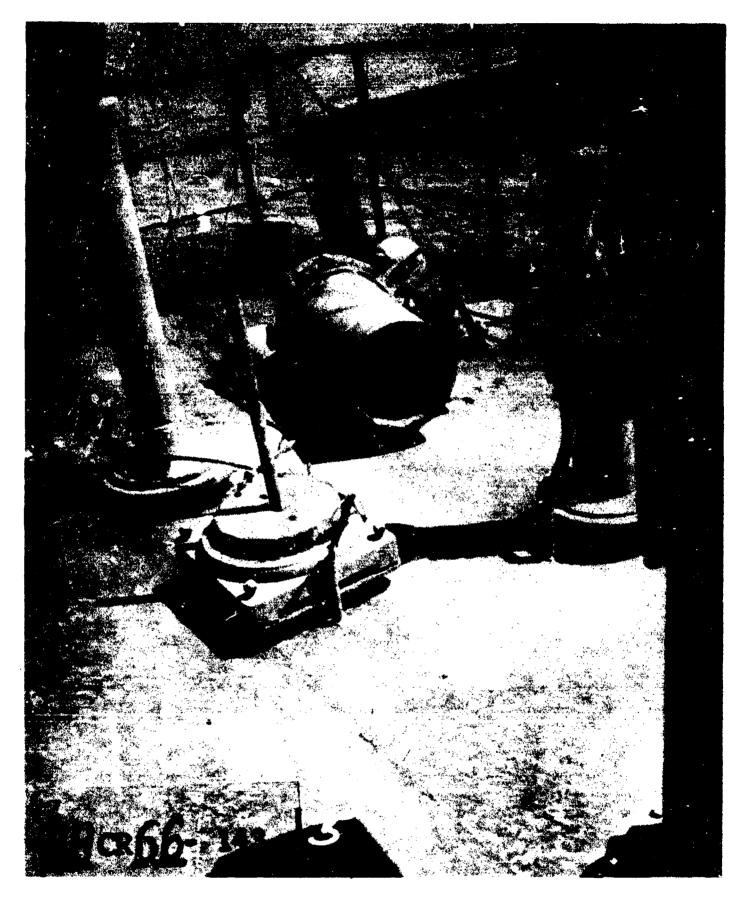
AB-CR-66-143-5. Secondary control station showing the standard compass on deck.

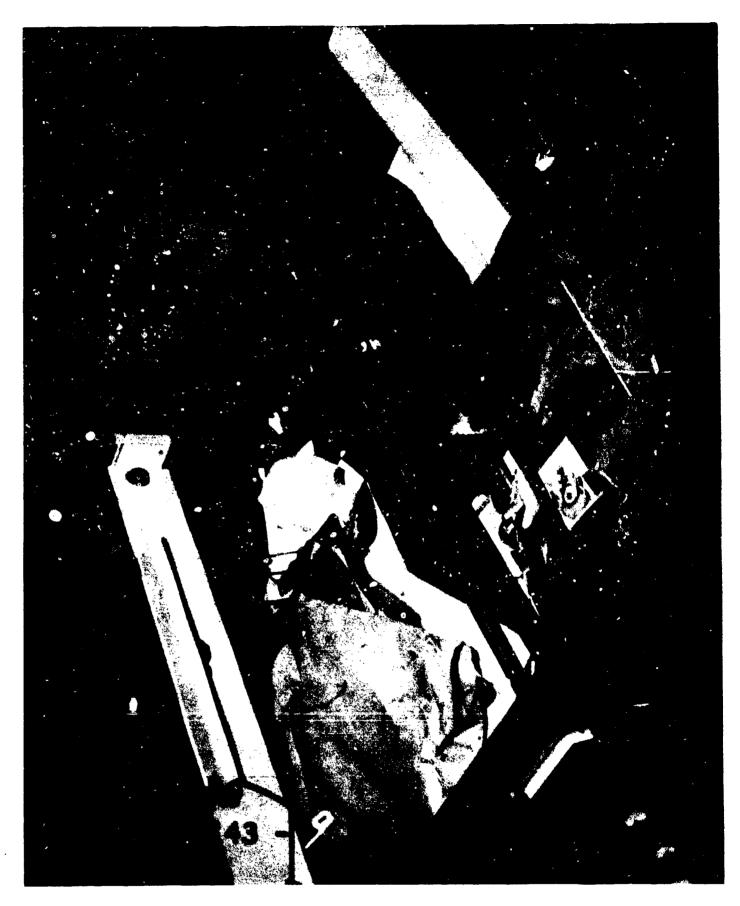
AB-CR-66-143-9. Looking down on the DRT located in the chart house showing the broken glass.

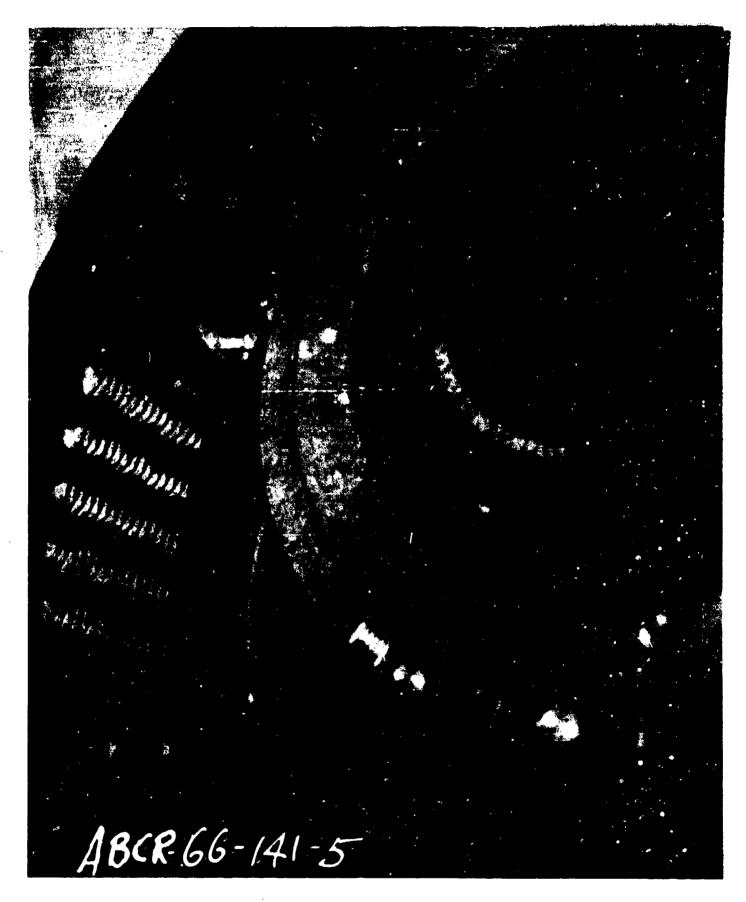
AB-CR-66-141-5. Master gyro-compass located in the I.C. room. Guide pin is out of guide slot.

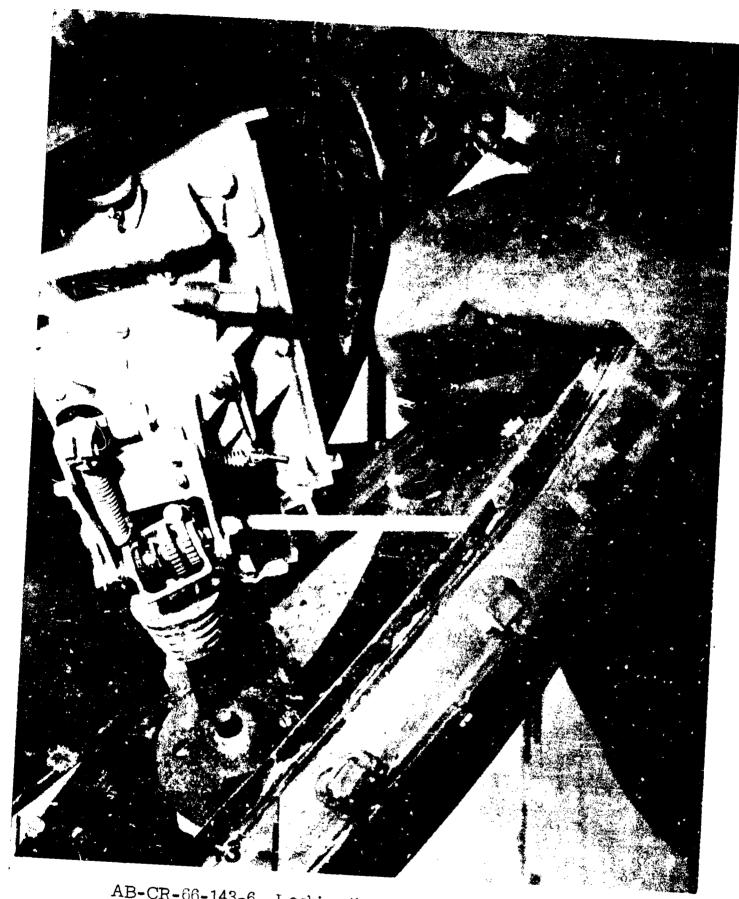
AB-CR-66-143-6. Looking through the rear door of the port 24" searchlight showing the general internal damage.
